AIRCRAFT GROUND-FLOTATION INVESTIGATION PART V DATA REPORT ON TEST SECTION 4

W. BRABSTON and W. HILL, JR.
U. S. ARMY ENGINEER WATERWAYS EXPERIMENT STATION

TECHNICAL REPORT AFFDL-TR-66-43, PART V AUGUST 1966

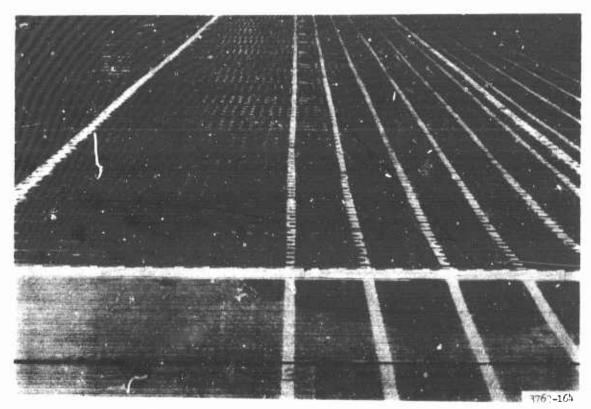
Fig 8. Lane 7, item 2, prior to traffic

- Item 2. Fig 8 shows item 2 prior to traffic. The M8 mat surface did not have a large number of breaks at 200 coverages when the item was considered failed due to roughness (Figs 9 and 10). At coverage levels near the failure point, the panel ends at the mat joint near the center line began to project upward (Figs 9 and 10). The rated CBR of the item was 4.9.

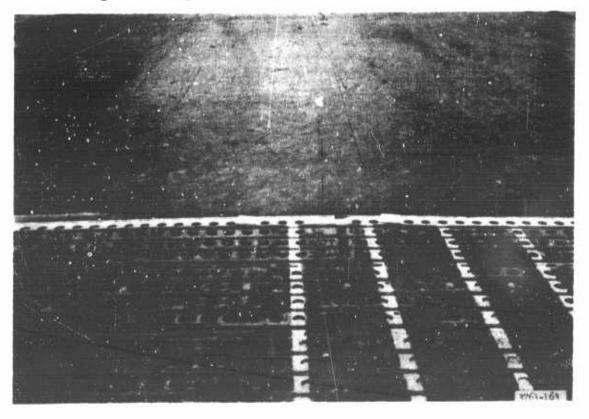
Fig 11. Lane 7, item 3, prior to traffic

- Item 3. Item 3 prior to traffic is shown in **Fig 11**. The item was in serviceable condition at 80 coverages, but had greatly deteriorated when data measurements were again taken at 128 coverages (**Fig 12**). After studying data collected at 128 coverages, it was decided to antedate the time of failure to 100 coverages. Failure was due to excessive rutting. The rated CBR of the item was 9.3.

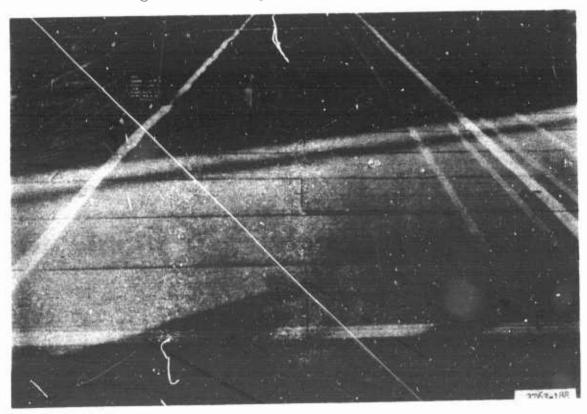
Fig 13. Lame 8, item 1, prior to traffic

- Item 1 is shown prior to traffic in Fig 13 The item held up well under traffic and did not have an excessive number of mat breaks at any time. Traffic was applied to the 460-coverage level when the item was considered failed due to roughness (Fig 14). The rated CBR for the item was 2.4.
- Item 2. Fig 15 shows item 2 prior to traffic. On mat runs having the mat joint located near the lane center line, the panels deformed in a concave upward shape along their length causing the panel ends to extend upward at the joint. This condition contributed to transverse and diagonal roughness in the lane. No mat breaks occurred during testing. At 142 coverages the item was considered failed due to roughness (Figs 16 and 17). The rated CBR was 4.0.

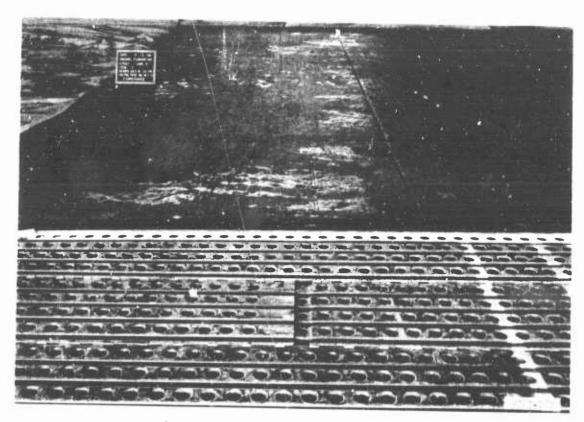
Fig 18. Lane 8, item 3, prior to traffic

Item 3 prior to traffic is shown in Fig 18. The item remained in good condition through 20 coverages with rut depths averaging 1.56 in. Continued trafficking resulted in progressive rutting and failure of the item at 62 coverages (Fig 19). The rated CBR for the item was 9.8.

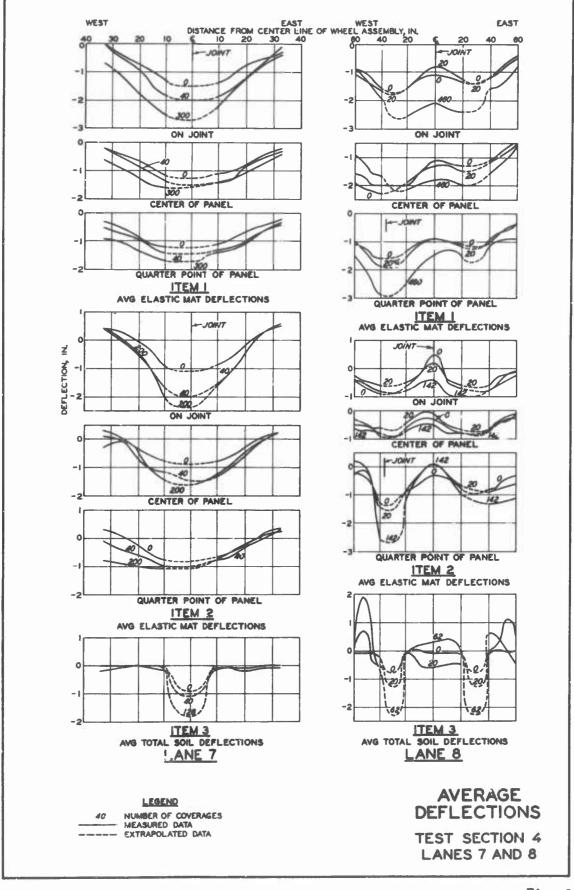
Fig. 24

- b. Deformation. Average cross-sectional deformations are represented in Fig 23 for the two typical mat runs. Deformations recorded at 20 and 142 coverages are shown. Maximum deformations occurred along paths on both sides of the lane center line. The center-line profile plot in Fig 24 illustrates the deflecting of panel end joints that developed with trafficking.

Measurements for the profile plot in Fig 24 were made to one side of the center-line ridge to be more representative of the entire item.
- c. Deflection. Average total soil deflections under static load of the load wheels are plotted in Fig 25 for 0, 20, and 62 coverages. Increasing deflections were consistent with increasing number of coverages. Maximum average deflection was 2.3 in. at failure of the item. Elastic subgrade deflections are shown in table 1 and reached 0.5 in. at failure.
- d. Rolling resistance. Drawbar-pull values are given in table 1.
 Rolling drawbar-pull values increased with increasing traffic coverages. Initial and peak values measured were slightly inconsistent with number of traffic coverages.
